# Technical Service Bulletin

## 21 Rattling/jarring noise from engine - 2.0 TFSI EA888 transverse

21 13 15 2027585/4 June 24, 2013. Supersedes Technical Service Bulletin Group 21 number 12-09 dated May 16, 2012 for reasons listed below.

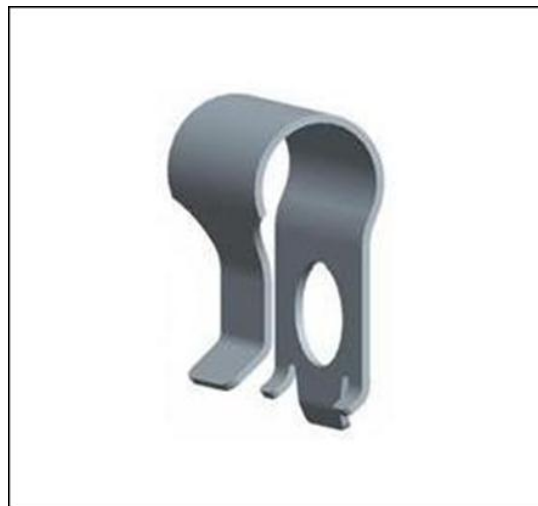
**Figure 1.** Spring clip

Because of exhaust gas pulsations, the wastegate flap and rods vibrate at the start of the boost air control. This vibration causes rattling or jarring noises.

A spring clip (**06J145220A**) must be fitted on the wastegate adjustment (Figure 1).

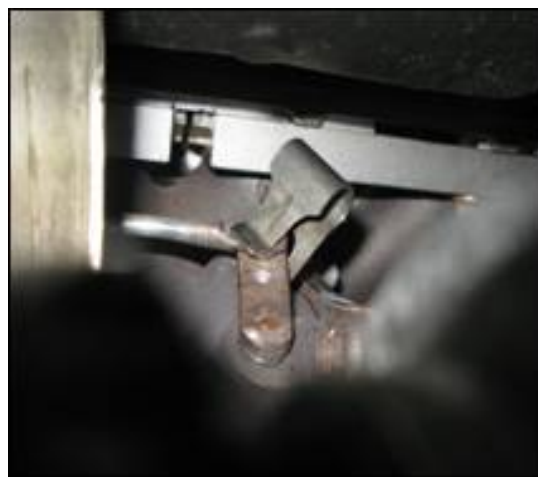
**Figure 2.** Wastegate linkage with clip fitted from the side.

1. Remove the noise damping according to the instructions in Elsa: *Repair Manual >> Body >> Body Exterior >> 50 Body Front >> Removal and Installation >> Noise Insulation.*
2. Remove the drive shaft protection.
3. Fit the clip from the side (Figure 2).

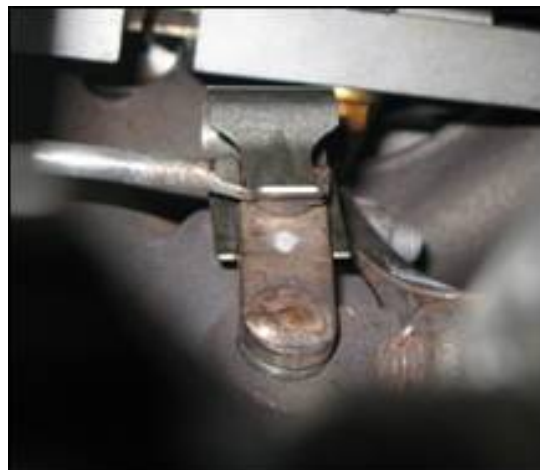
**Figure 3.** Wastegate linkage with clip in final position.

4. Turn the clip to the left until the lugs slot in (Figure 3).

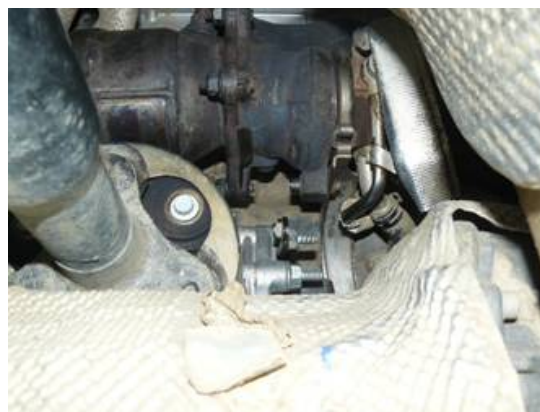
**Figure 4.** Reach through and position clip.

1. Remove the propshaft heat shield according to the instructions in Elsa: *Repair Manual >> Body >> 66 Exterior Equipment >> Removal and Installation >> Underbody Trim Panels >> Heat Shields, Driveshaft*
2. Reach through from behind to position the clip (Figure 4).

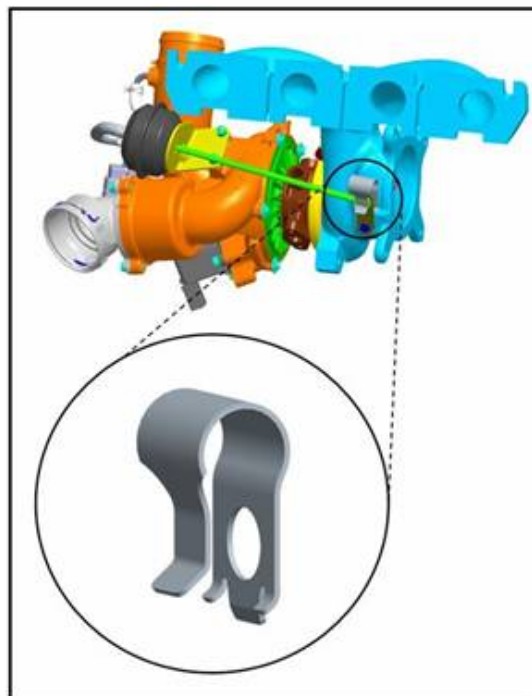
**Figure 5.** Fit the spring clip on the wastegate adjustment.

3. Fit the spring clip on the wastegate adjustment (Figure 5).

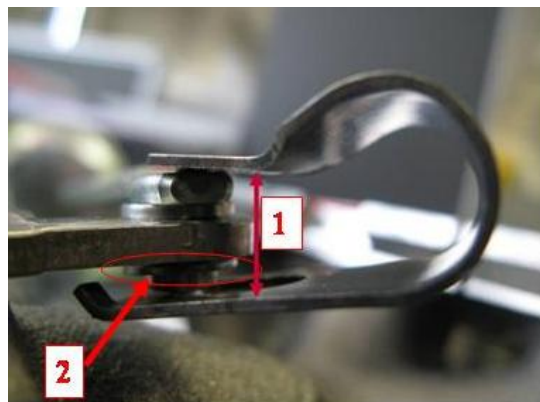
**Figure 6.** (1) Maximum opening of spring clip.

**Tip:** The spring tip must not be overstretched. The maximum opening of the spring clip is 14 mm. In the example in the image, the opening is approximately 10.5 mm (Figure 6).

The spring clip must be replaced after every removal.

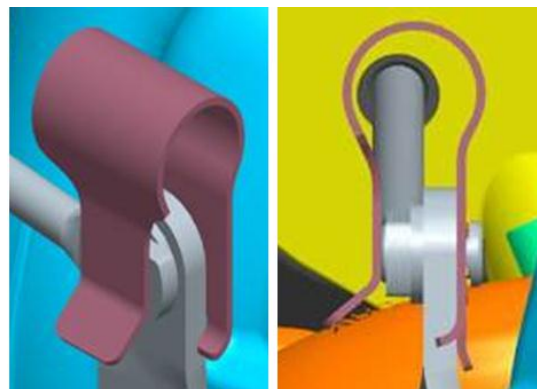
**Figure 7.** *Spring clip correct fitting.*

4. After fitting the spring clip, check for correct fit (Figure 7).

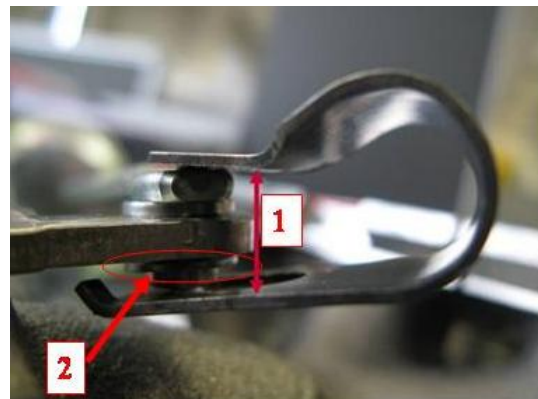
**Figure 8.** *(2) Position of the original circlip.*

5. Check the position of the original circlip (Figure 8), and correct if necessary.
