This Service Information bulletin supersedes SI B41 04 08 dated August 2009.

| E46 (3 Series) |

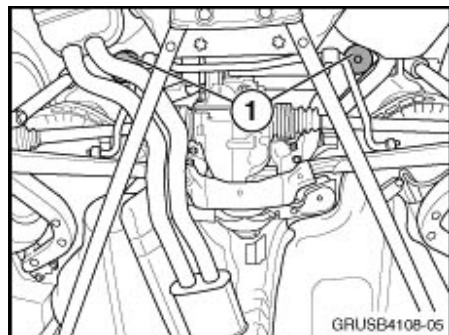
Under certain circumstances, a fracture in the steel body structure could form in the area around one of the rear axle carrier mounting points. As a result, a distinct clicking noise can be heard from the area of the rear axle carrier during certain driving conditions. Specifically, the noise may be heard during load reversals on the rear axle, such as when starting from a stop, engaging forward or reverse gears, or when rapidly changing gears.

Visually inspect the left rear mounting point for the rear axle carrier (left leader for #1 illustrated). If a fracture in the sheet metal is present, the length of the crack must be measured. If multiple cracks are present, measure the longest one.

- If the length is 20mm or **less** and the vehicle was produced **prior to** 10/2004, proceed to Procedure A.
- If the length is 20mm or **less** and the vehicle was produced **from** 10/2004, proceed to Procedure B.
- If the length is **greater** than 20mm, proceed to Procedure B.
