| E46 (3 Series) US specification models only |

## SITUATION

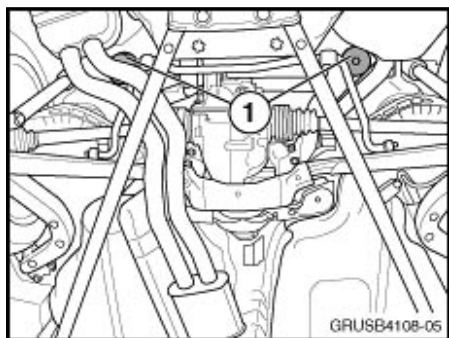
8. Both rear bushings (1) should separate from the rear axle support by several inches. The rear axle carrier should only be lowered under its own weight and should not be forced down, or damage to other components could result.

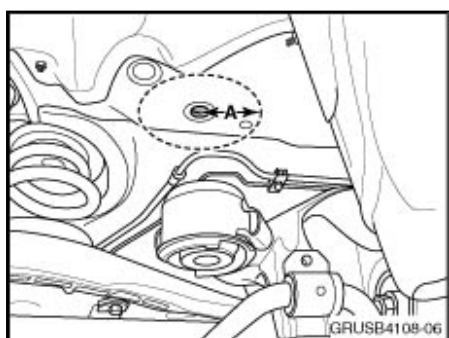
10. Inspect the left rear axle support on the body of the car. The area to be inspected is a radius of A=6 inches from the center of the bolt hole for the bushing. Most fractures that occur will start at a weld point and grow outward.

11. If no cracks are present, no repairs are necessary. Continue to step 15.
12. If any fractures and/or cracks are visible, measure their lengths.
13. If the crack measures 20mm or less and the car was produced up to 10/2004, it will require a repair. Refer to [SI B41 04 08](#) - Procedure A Structural Epoxy.
14. If the crack measures more than 20mm or if any length crack exists on a car from 10/2004, it will require a replacement of the rear axle carrier. Refer to [SI B41 04 08](#) - Procedure B Replace Rear Axle Support.
15. Resecure the rear axle carrier to the vehicle. Inspect the original bolts and replace them if they are damaged or heavily corroded.
