E46: M3 coupe/convertible with S54B32 produced from 02/12/2001 up to 05/22/2003

The connecting rod bearings installed in M3 coupe/convertible vehicles produced from February 2001 through May 2003 were not manufactured to BMW quality standards. As a result, the connecting rod bearings are susceptible to overheating and subsequent premature failure if vehicles are driven at higher engine speeds over an extended timeframe. This condition will cause a total engine failure.

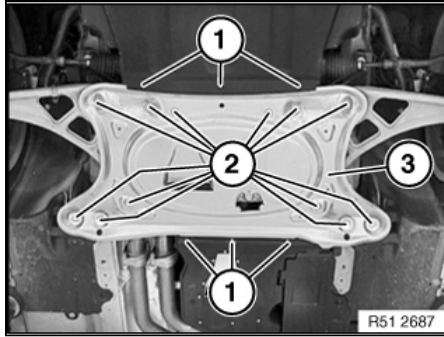
4.Install special tool p/n 88 88 6 00 0 200 ("engine brace") in engine compartment in order to support engine during the repair.  
For installation instructions refer to RA 11 13 000

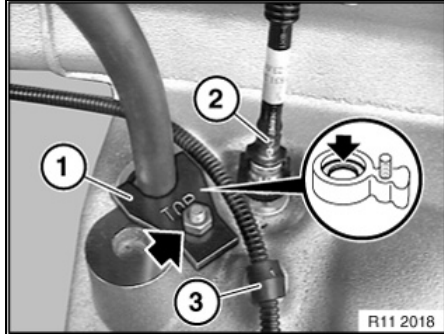
5.Remove engine splashguard. Remove thrust (3) plate on front axle support. For removal instructions refer to RA 51 71 374.

When reinstalling thrust plate, use a set of new M10x30x1.5 screws provided in the parts kit. Then, the reinforcement plate screws must be tightened in two stages:

- first, torque with 59 Nm

- then, angle torque to 900 using Torque Angle Measuring Tool p/n 90 88 6 009 120 (available through the Automatic Tools Shipment Program)

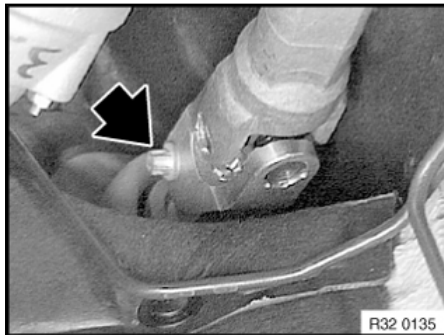
- 7.Remove dipstick holder (1) from the oil sump, and remove dipstick.
- 8.Detach oil condensate return hose (2).
- **IMPORTANT:**
- When reinstalling the oil dipstick, replace the O-ring (as indicated by black arrow) included in the parts kit.

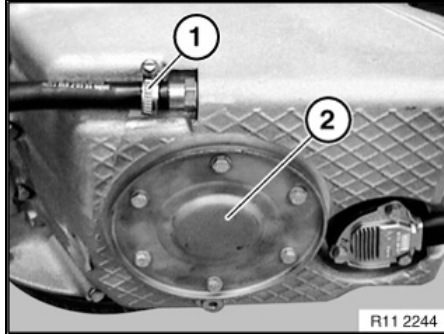
- 18. Detach return hose (1) from oil sump.
- 19. Remove cover (2) from oil sump.
- 20. Disconnect oil level sensor connector.

Replace gasket for sump cover (2) when reinstalling oil sump (gasket is provided in the parts kit)

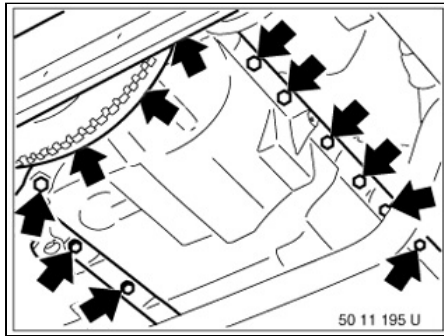
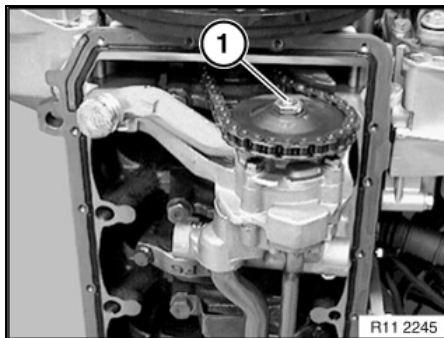
- 21. Unfasten oil sump screws and carefully remove oil pan.

Three screws on the left side of the oil pan (near the oil condensate return hose) are 5 mm longer than the rest of them.

When reinstalling, use new oil pan gasket p/n 11 13 1 437 237 (ordered separately). Also, apply a small amount (bead approximately 3mm wide and 2mm high) of HYLOMAR Sealing Compound (p/n 81 22 9 400 339) in areas around timing cover/engine block/bell housing joints.

Then, torque down oil pan screws (M6) to 10 Nm when reinstalling.

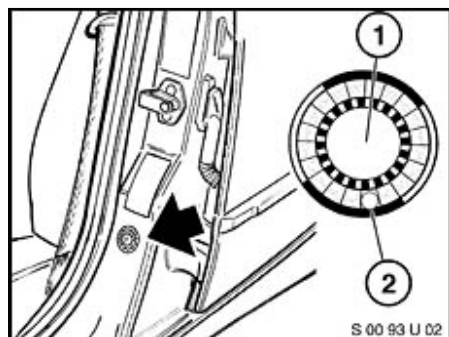
This Service Action has been assigned code number **422**. After the vehicle has been checked, and corrected if necessary, obtain a label (SD92-267) and:

- emboss your BMW dealer warranty number in the middle of the label (1);
- punch out code number **422** (2) printed on the label and,
- affix the label to the **B** pillar as shown.
