February 16, 2009

Supersedes Technical Service Bulletin Group 61 number 09-01 dated January 13, 2009 for reasons listed below.

Model(s)	Year	VIN Range	Vehicle-Specific Equipment
TTR (8J9)	2007 – 2009	All	Not Applicable

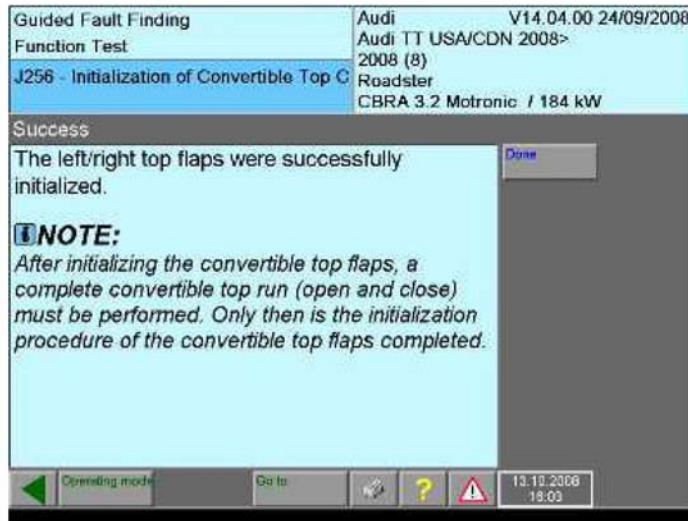
A fault in the potentiometer in the cover flap motors sends an implausible signal to the convertible top control unit. The convertible top operation control unit stops the top operation when the cover flaps are fully open.

**Figure 1.** GFF specifies that a complete convertible top run be performed immediately after the initialization.

1. Replace the flap motors with part number 8J0 959 311 A.

Do not replace the entire side flap assembly or J256 Convertible Top Control Unit. Only the flap motors need to be replaced.

2. Perform the adaptation for the flap motors in GFF.

When performing the side flap motor adaptation, it is imperative that a complete convertible top run be completed immediately after the initialization. Do not press the 'done' button before doing so, otherwise the adaptation will not be complete. This step is specified in the GFF test plan.
