## Panoramic roof: Glass roof jams or cannot be opened, drive unit makes rattling noises

Topic number	LI77.21-P-063617
Version	2
Design group	77.21 Panoramic roof
Date	04-12-2016
Validity	BR117 with code 413 BR156 with code 413 BR176 with code 413 BR205 with code 413 BR222 with code 413 BR253 with code 413 BR292 with code 413
Reason for change	Validity extended to model series 117, 156, 176, 222, 253, 292.
Reason for block

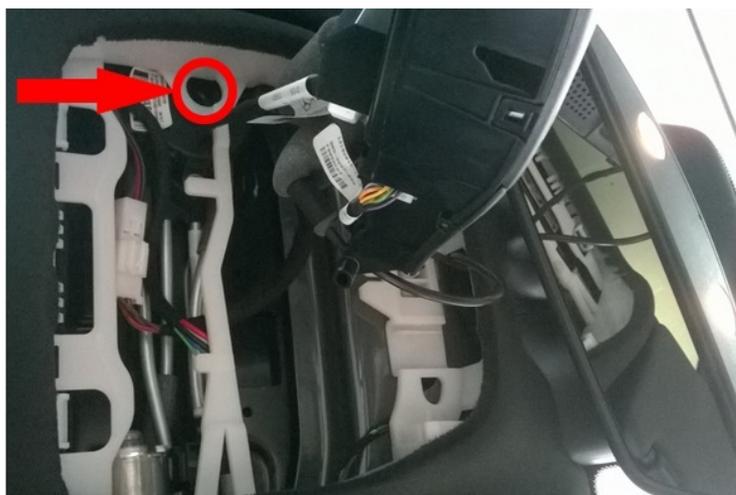
Notbetätigung ASD-Glasdach.jpg:

Unplug connectors of both drive motors, use a suitable tool to operate the emergency override of the drive unit (Figure 1, shown on the X253; on other models it may be necessary to lower the headliner) and open the glass roof far enough to allow access to the bolts of the glass roof. When doing this, have a second person push the glass roof upwards and backwards while supporting it at the front and rear.
