Connection offline Service campaign 34F4 Replacing gear oil

Transaction No.: 2035734/5 Release date: 07-Mar-2014

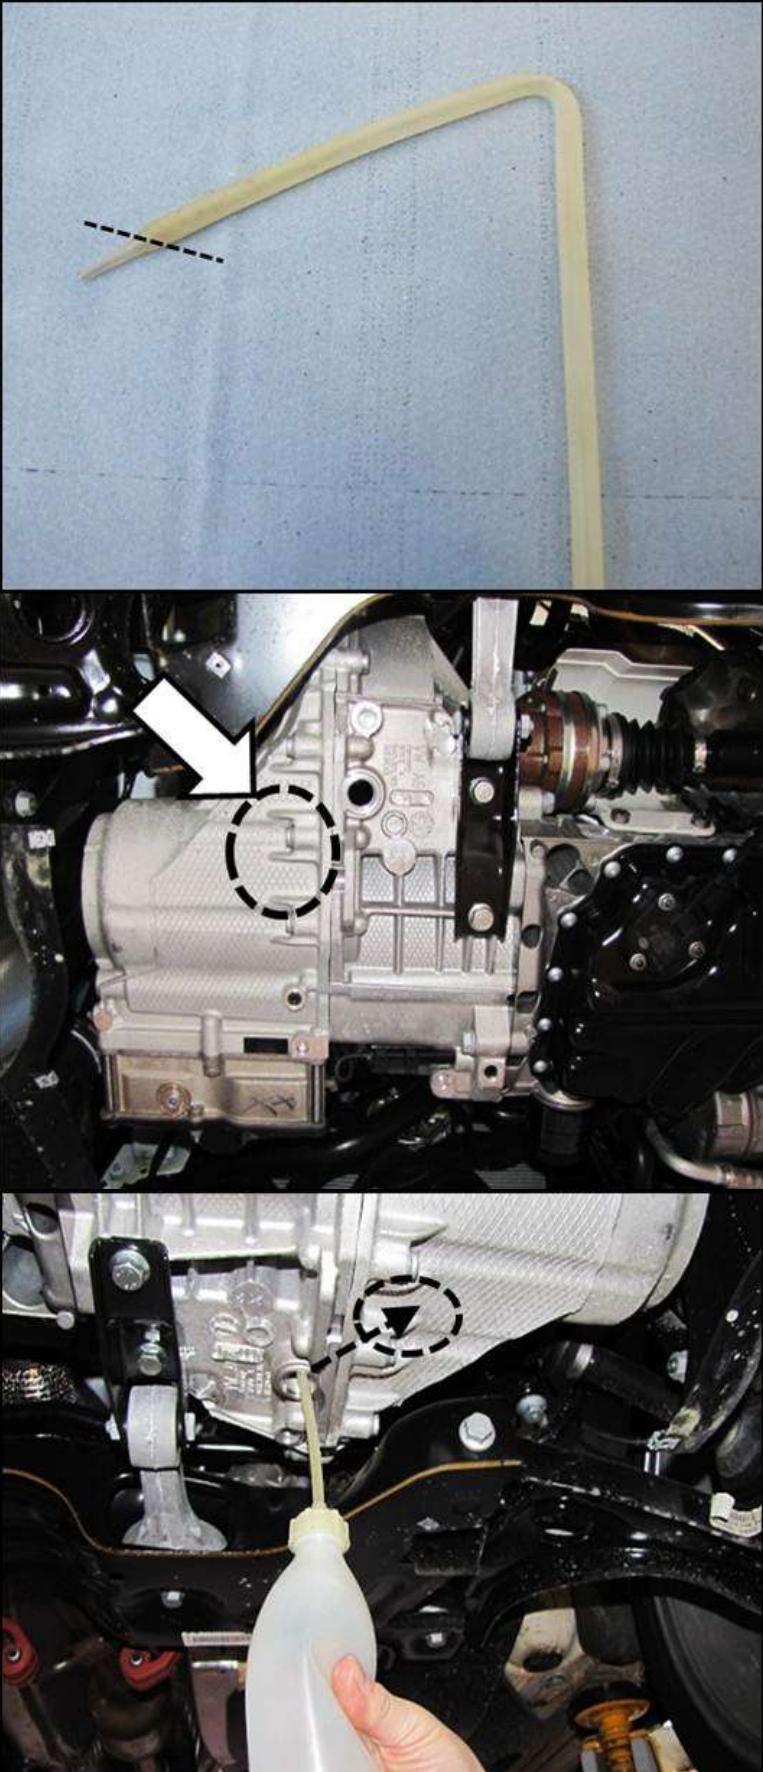
The remaining oil collects in the lowest part of the gearbox housing (marked area).

- Guide suction tube of bottle into marked area (lowest part of gearbox housing) and draw off remaining gear oil.

• A quantity of up to 100 ml of oil can remain in the housing.
