Technical product information

Transaction No.: 2026513/8

Engine: rattling noises from front/engine compartment when starting engine

Release date: 02-Jul-2013

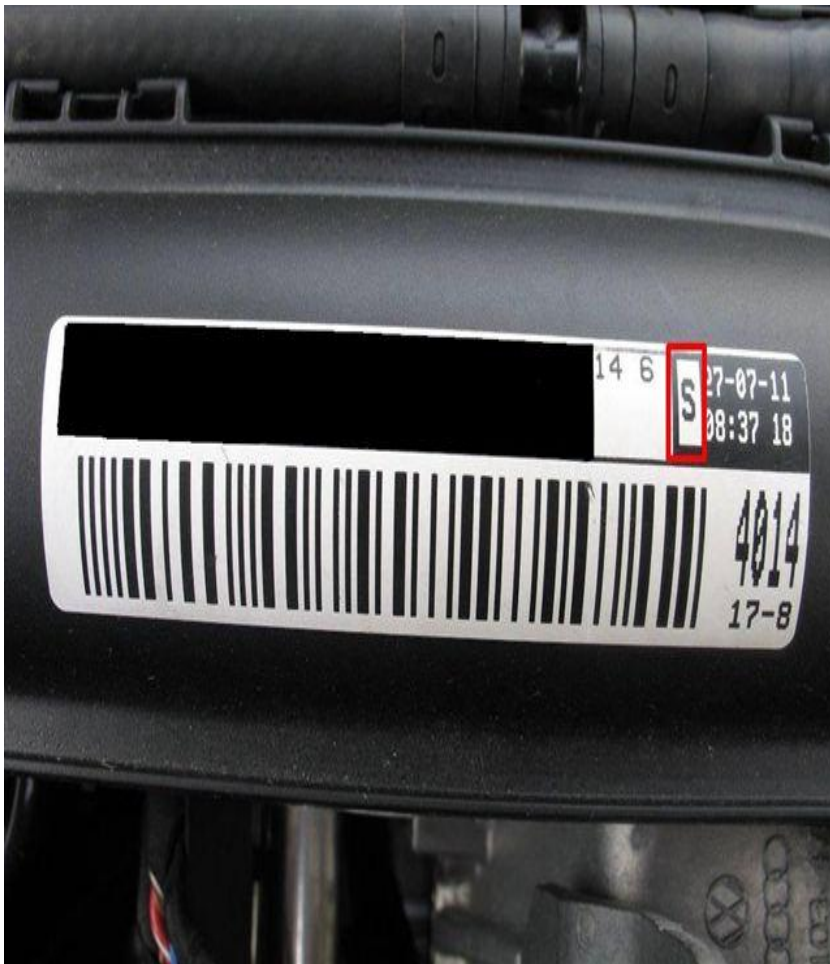
Illustration 1

- For the identification of the plant observe the sticker on the boost pressure pipe (illustration 1, in red) or on the intercooler.
- With exchange engines note the sticker on the cylinder block (illustration 2, in green) for the identification of the engine batch number.

S = Salzgitter plant

M = Mlada Boleslav plant

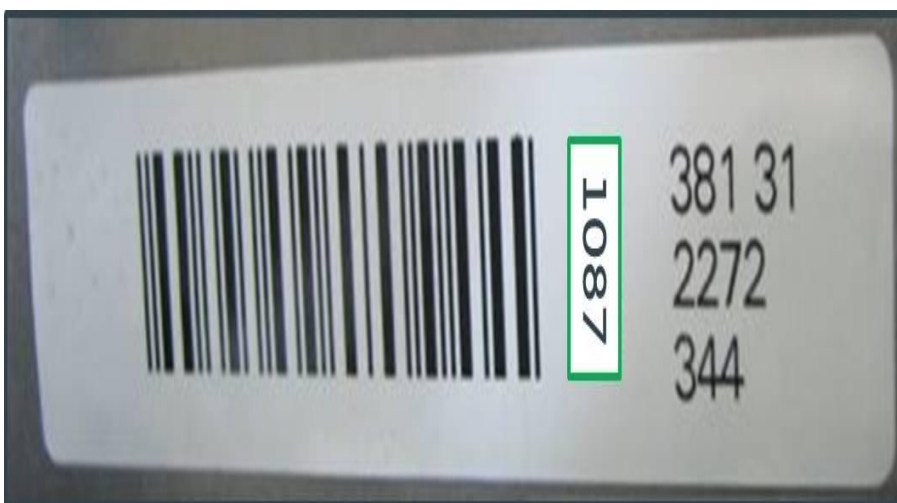
Illustration 2

- CBZ* 462774 (Mlada Boleslav).
- CBZ* 714253 (Salzgitter).
- Exchange engines from engine batch number: 1087 (illustration 2, in green).

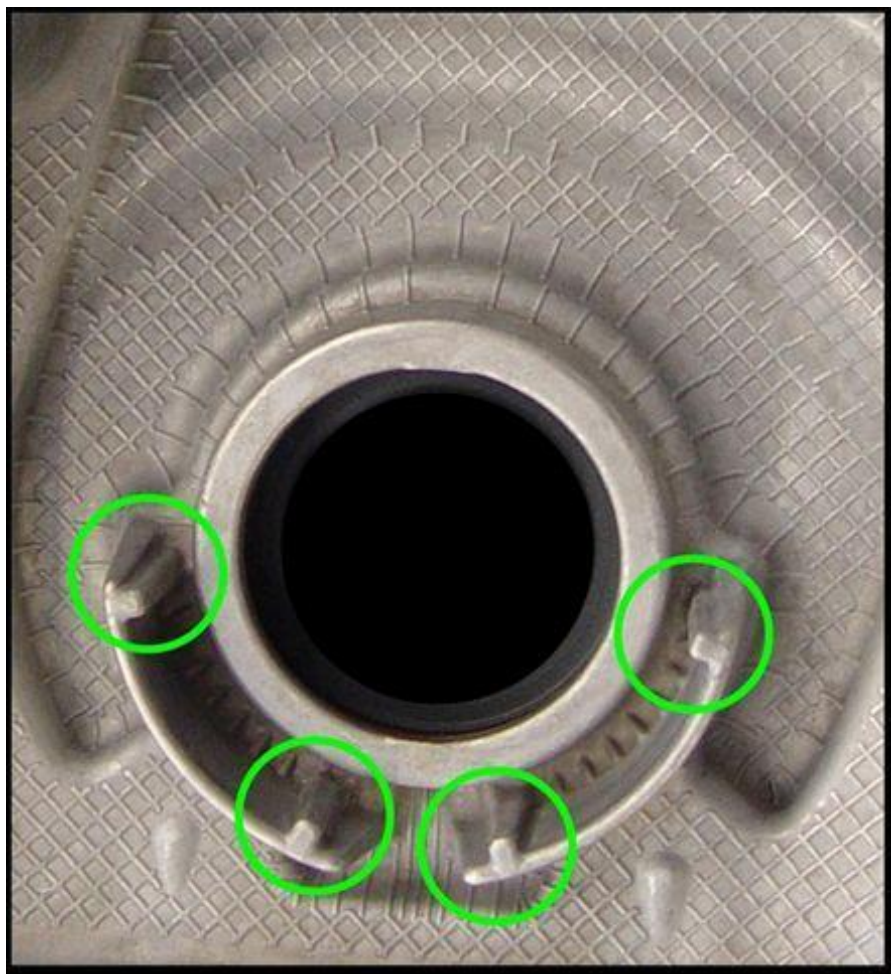
Illustration 3) green circles = timing chain protection cover

Check whether a guard for the timing chain available is fitted on the chain box (illustration 4, green areas).
