Technical product information

2058102/28

Transmission: gearbox warning lamp/various event entries

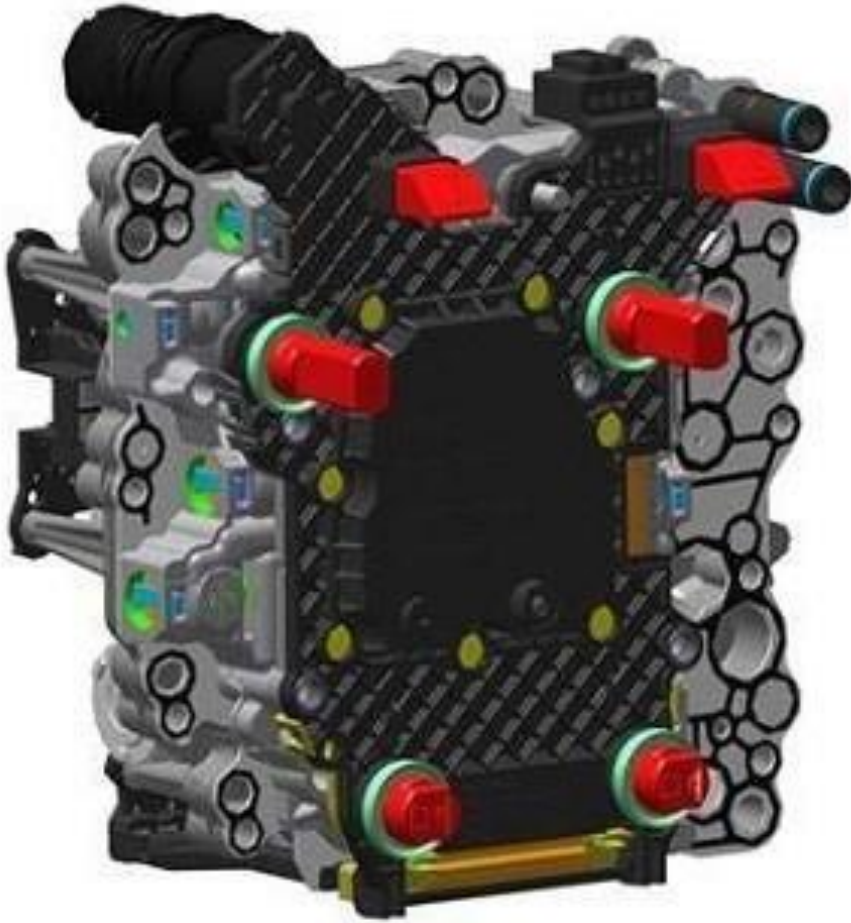
Illustration 1) mechatronic unit/gearbox control unit

- The sensitive sensors on the back of the mechatronic unit must not be touched.
- The mechatronic unit must not be propped up against the sensitive sensors on the back of the mechatronic unit (see illustration 1, in red).

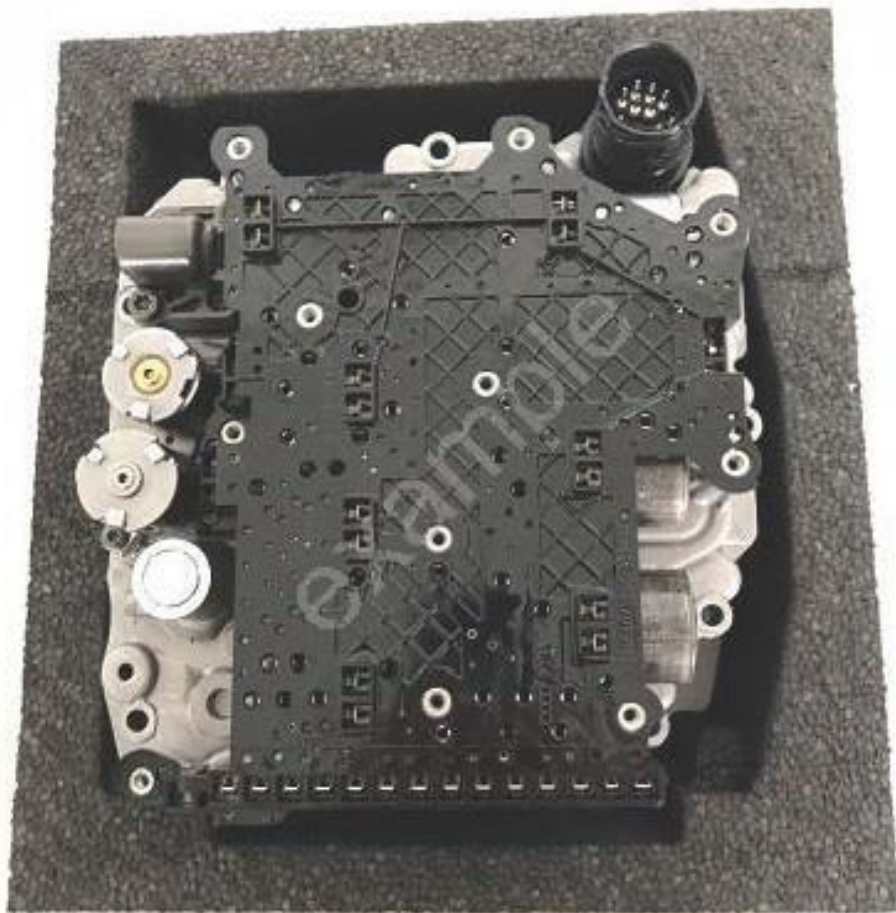
Illustration 3) mechatronic unit placed in the installation aid

- After removing the mechatronic unit, place it in the installation aid. Remove the control unit from the installation aid in advance and securely place it in the packaging.
- After placing the mechatronic unit in the installation aid, with the sensors pointing down (see illustration 3), the contact plate must be removed from the mechatronic unit. Loosen and remove the bolts (see illustration 4 or 5).

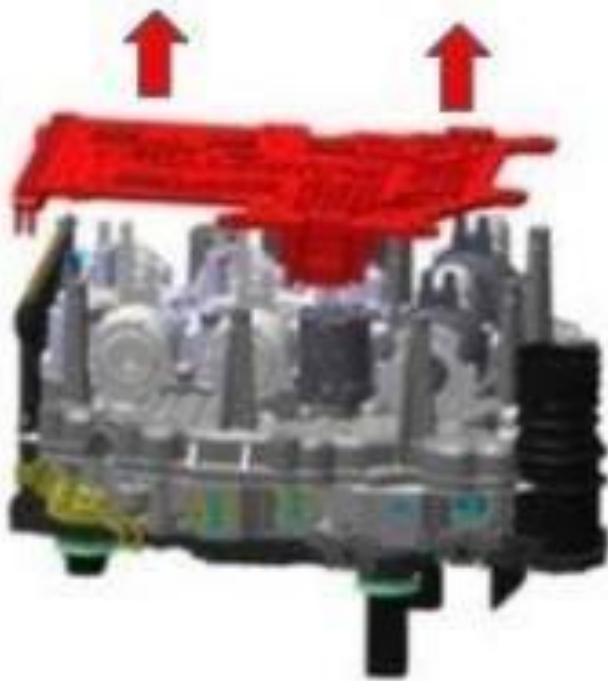
Illustration 6) detach contact plate from the mechatronic unit

- Without levering, carefully remove the contact plate (see illustration 6, in red) evenly upwards from the mechatronic unit (see illustration, red arrows), beginning with the upper corners. Make sure that the contacts of the valves are not bent or damaged.
