Connection offline Service campaign 34F4 Replacing gear oil

Transaction No.: 2035734/5 Release date: 07-Mar-2014

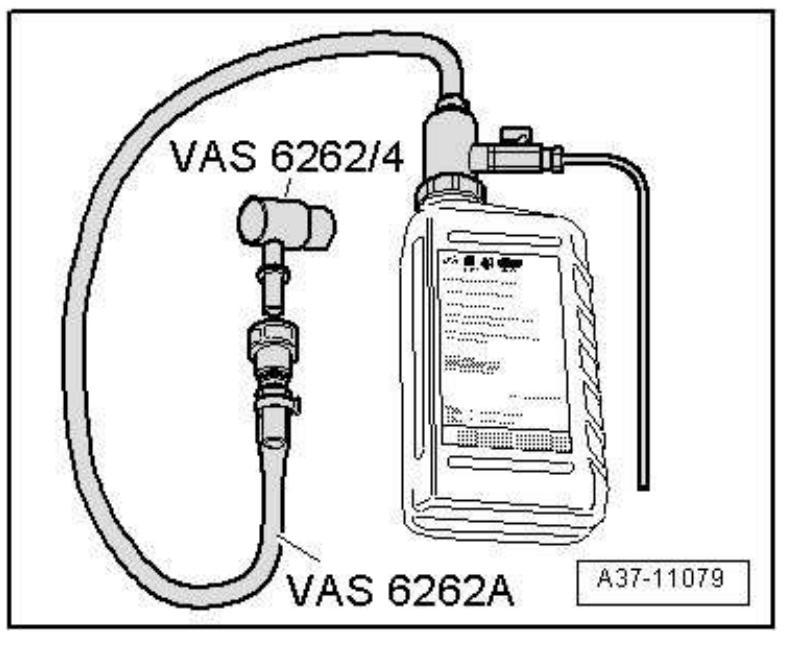
The remaining oil collects in the lowest part of the gearbox housing (marked area).

- Guide suction tube of bottle into marked area (lowest part of gearbox housing) and draw off remaining gear oil.

• A quantity of up to 100 ml of oil can remain in the housing.

- Fill up with **1.9 ltr.** of gear oil **G 052 512** \*\*.
